MUEGGE HOUSE HISTORIC STRUCTURE ASSESSMENT

SHF PROJECT NUMBER 2019-HA-005
DRAFT HISTORIC STRUCTURE ASSESSMENT – DELIVERABLE #4
OCTOBER 20, 2019

CHARLES MUEGGE HOUSE HISTORIC STRUCTURE ASSESSMENT

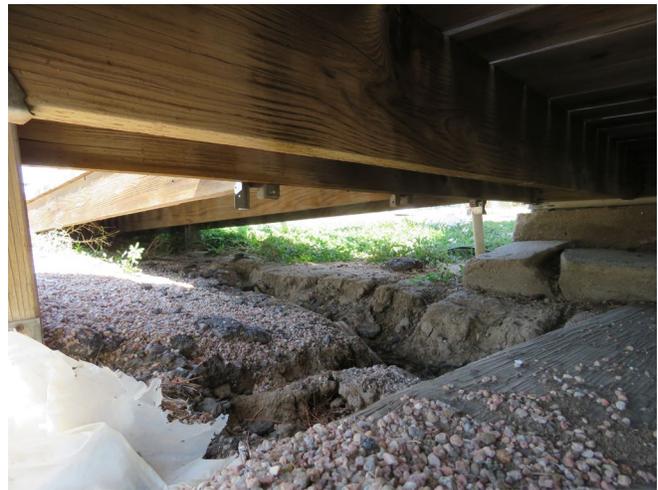
The Town has had issues with water infiltration at the handicap ramp on the south elevation. Water drains towards the ramp and the historic basement access, which is just below the ramp (see figure 2). The water enters between the house and the concrete retaining wall of the historic concrete stairs to the basement. The Town installed sand bags along the ramp to prevent the water infiltration, but those bag have now disintegrated.

Figure 2 Erosion under the wood deck from water drainage. Plywood is covering the historic stairs into the basement.

create positive drainage away from the building as recommended by *Preservation Brief 39: Holding the Line: Controlling Unwanted Moisture in Historic Buildings*. Add topsoil and reseed with native grasses after sitework is complete.

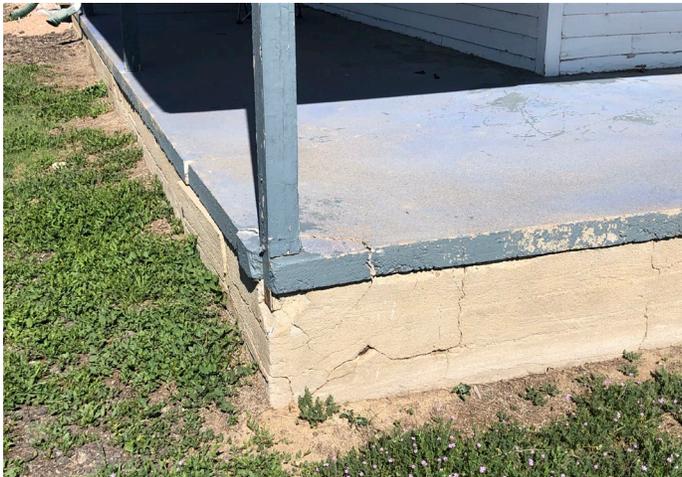
Figure 3 Cracks at Face of Concrete Porch and Weathering of the Concrete

The porch foundation, which was visible is in fair condition. There is significant horizontal cracking along the foundation wall and cracking at the corners where the columns bear (see Figure 3).

Where the concrete is displaced on the surface of the porch and is a tripping hazard, grind the concrete and fill any cracks with a flexible sealant. Monitor the cracking on the vertical face and if it continues to displace, cut out the section and repour.

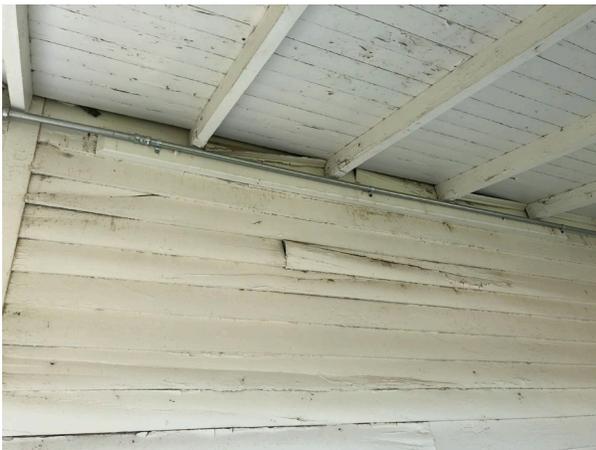
Figure 4 Damage from water infiltration at porch roof connection.

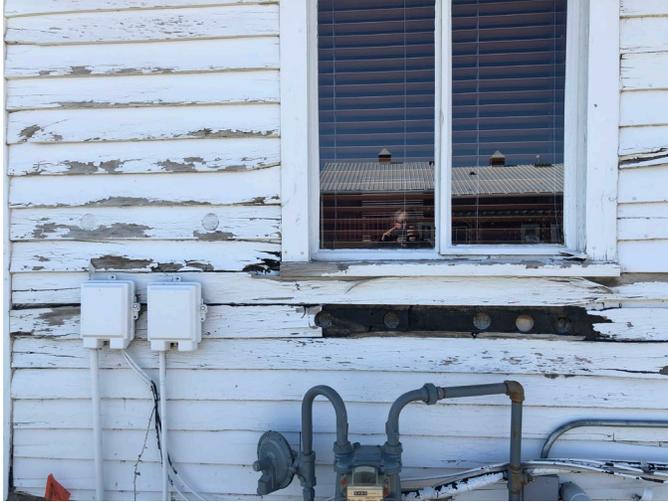
Figure 5 Deteriorated Wood Siding, Rotted Siding and Gaps at Plugs from Blown-in Insulation

Original House: The wood siding is in fair condition with some areas in poor condition. There is extensive evidence of past paint failure under the current paint. Additionally, during the SHF#2000 grant, holes were drilled in the siding and above and below the windows to install blown-in insulation. The boards have significant deterioration with gaps between the plugs and wood siding where the plugs have shrunk. The north elevation, at the first floor has extensive damage, where water has dripped behind the porch roof and damaged and warped the wood siding at the first-floor level (see Figure 4). Additionally, the siding has cobwebs and dirt covering the building. The bottom row of wood siding at the first floor is exhibiting more

Original House: Remove all wood siding that has the plugs and install new replica siding. This will prevent future water infiltration and possible wood framing damage. Epoxy all wood siding that have minor splits and replace siding that is

heavily warped, has splits that extend across over half of the length of the board or is rotted. When replacing this siding, inspect the wall framing and building paper for damage from water infiltration. If water damage exists, repair with replica members/material. Maintain the existing wood trim and repair the trim at Windows K & L. Sand the building to the next sound layer and paint the historic color. Although it appears that the historic color was always white, a historic paint analysis should be completed to document the historic color during its period of significance, which is 1948.

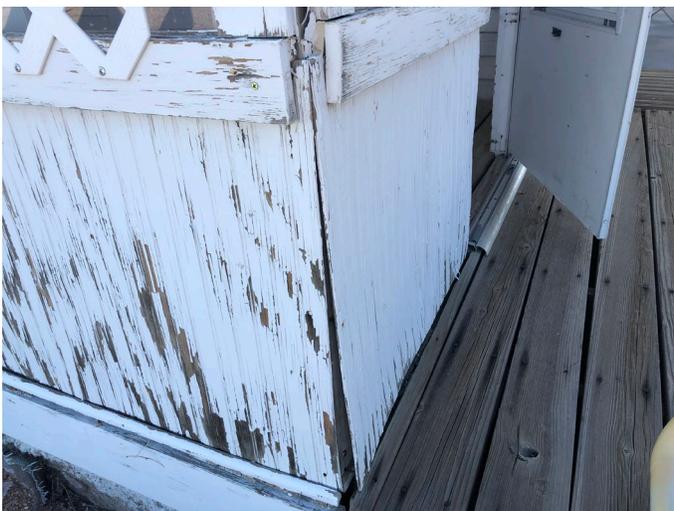
Figure 6 Panelized beadboard at enclosed porch addition. Note deteriorated paint and loose panels.

Enclosed Porch Addition: The panelized beadboard siding is warping and pulling away from the wall framing. The paint on the siding has extensive paint deterioration, exhibiting alligating and peeling areas (see Figure 6).

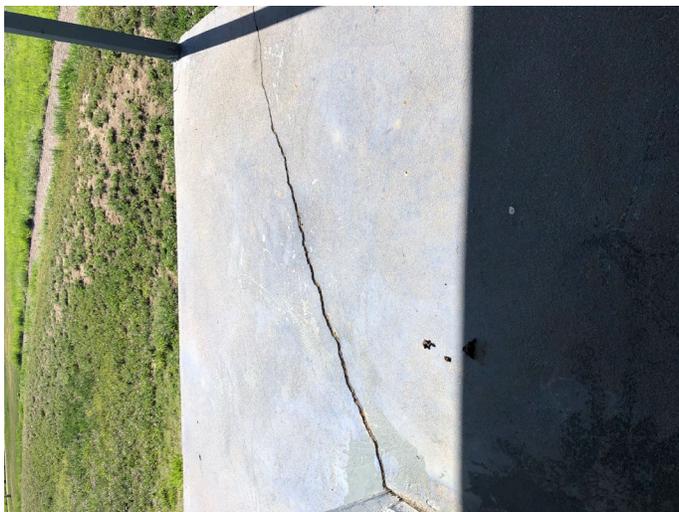
Figure 7 Large Crack and Alligating of the Concrete Porch

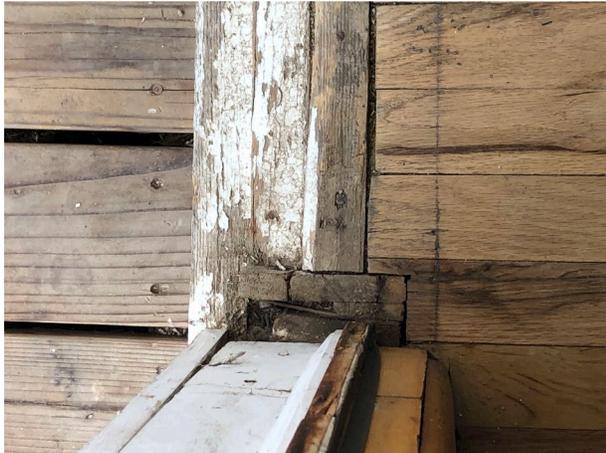
Figure 8 Evidence of the Door Being Widened

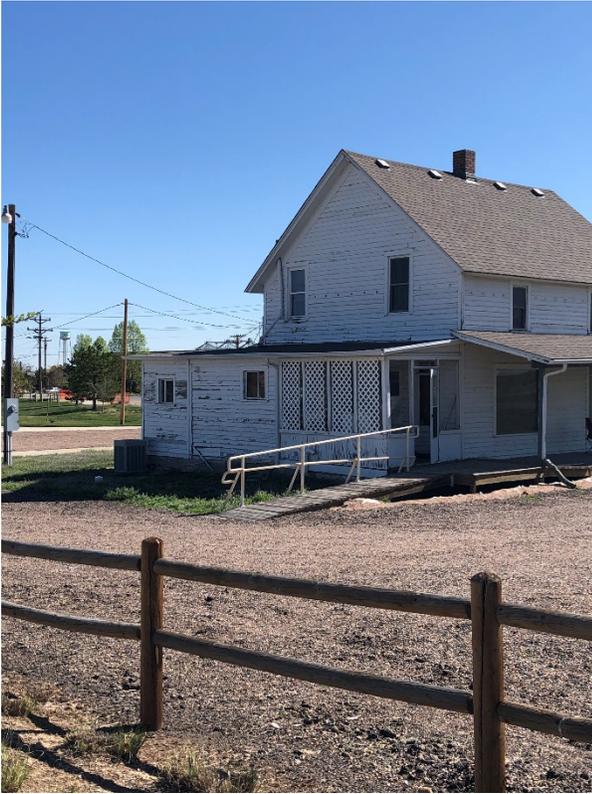
5.0 Looking Northeast at Drainage Toward Building and Handicap Ramp

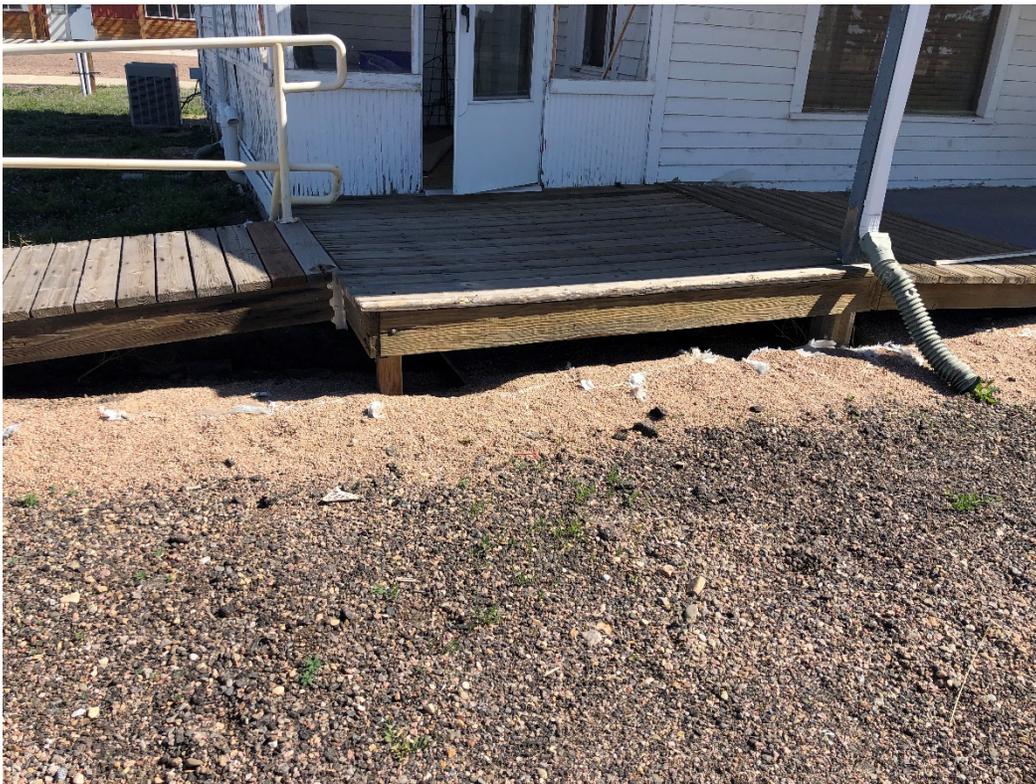
6.0 Drainage Issues – South Elevation at Ramp and Historic Basement Entrance Under Deck

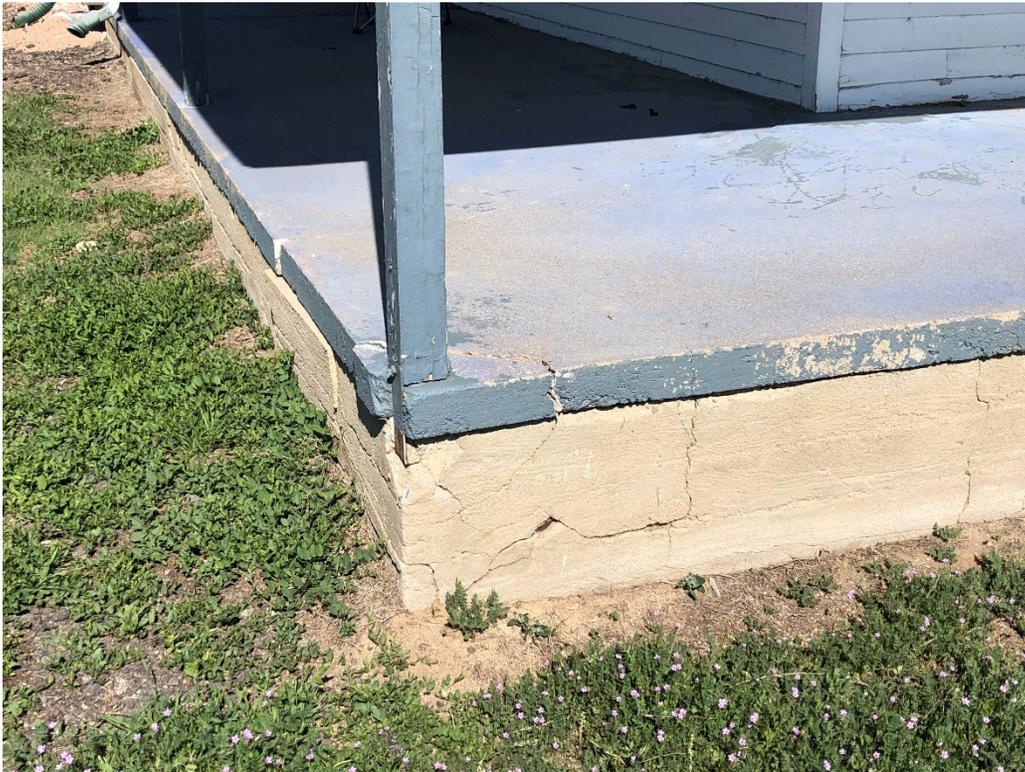
7.0 Crack at Southeast Corner of Porch

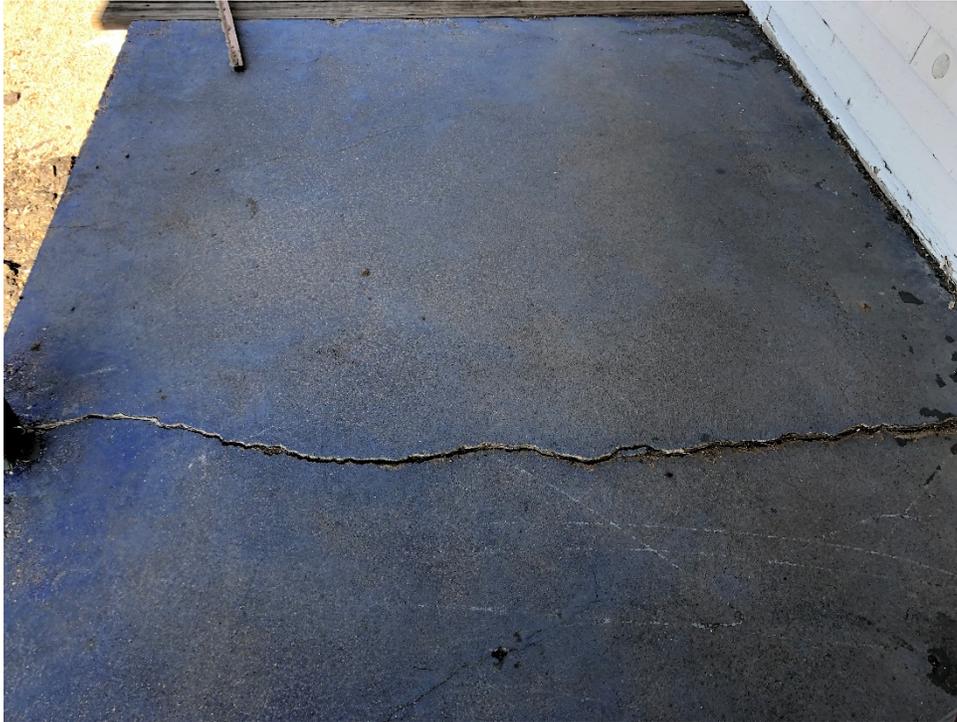
9.0 Cracks on Surface of Porch

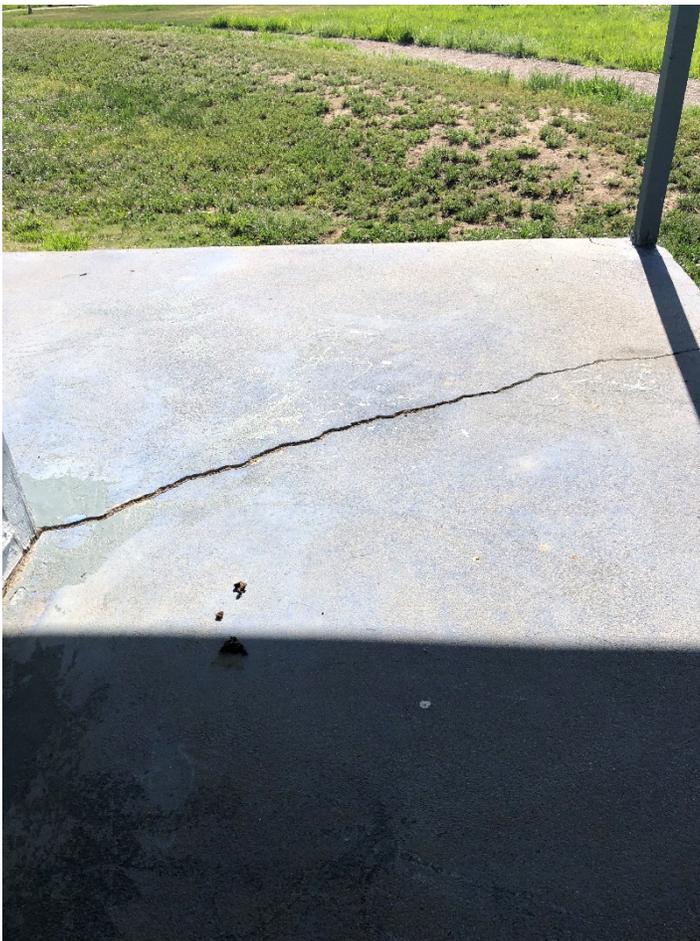
10.0 Cracks at the Southeast Corner of Porch

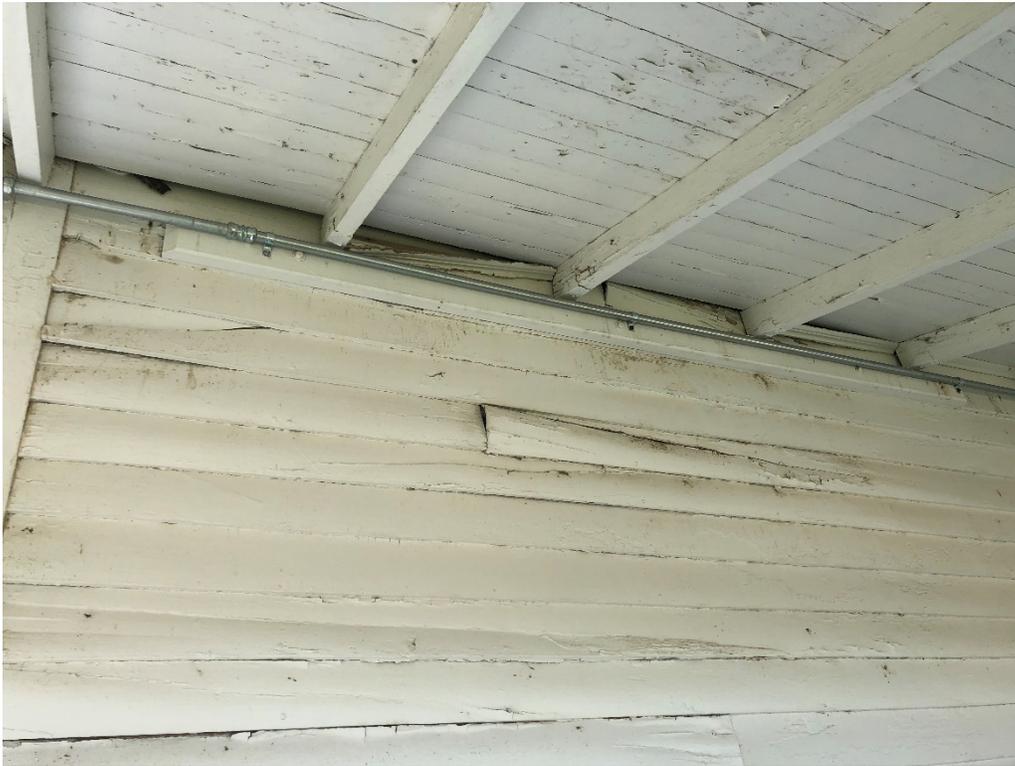
11.0 Siding Deterioration Due to Water Infiltration Between Roof and Wall

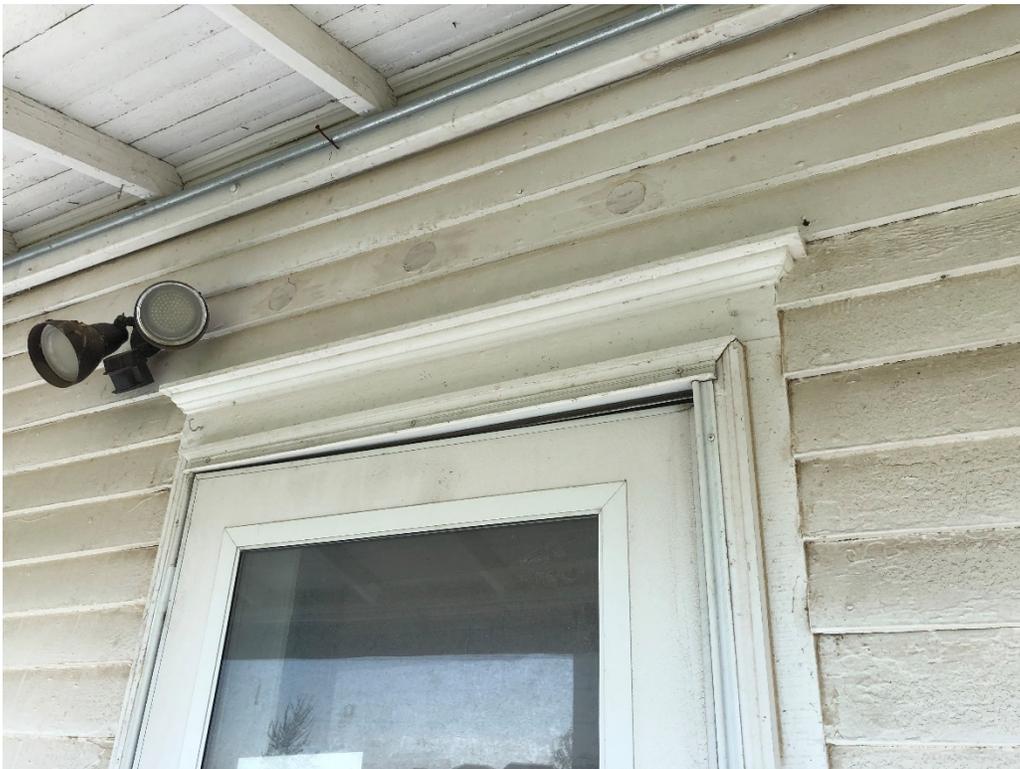
12.0 Holes in Siding Where Blown In Insulation was Installed

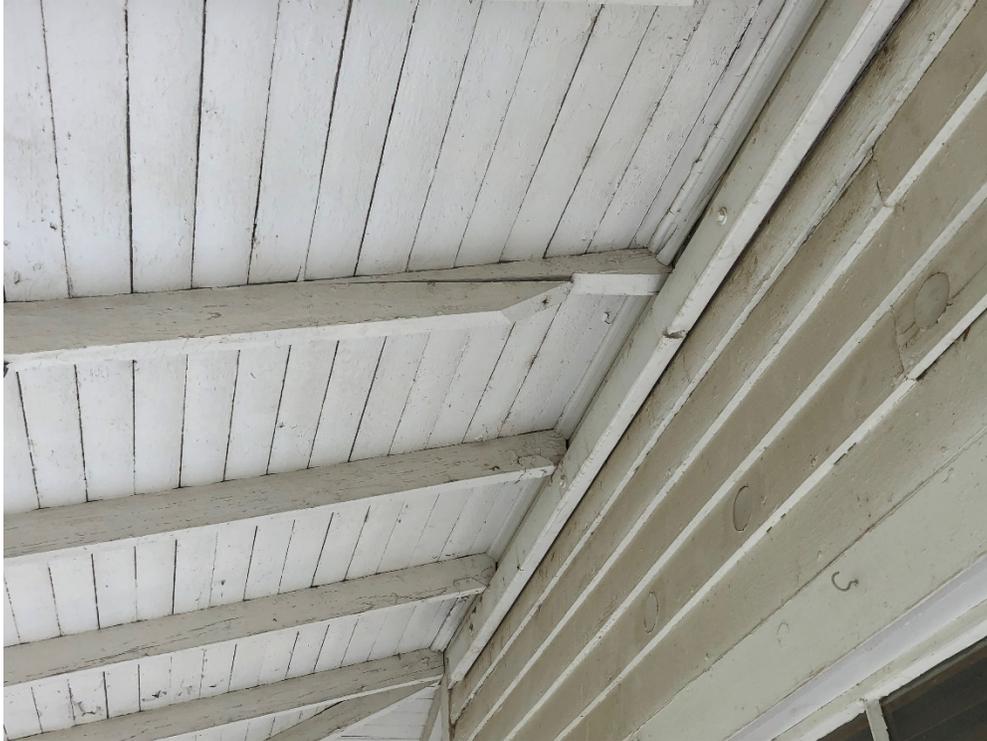
The roof framing is in good condition, except for three, split roof joists on the porch.

13.0 Split in Porch Rafter

Replace the damaged roof joists with replica joists at the porch. Load calculations were not completed as a part of this grant, so load capacities are not known.

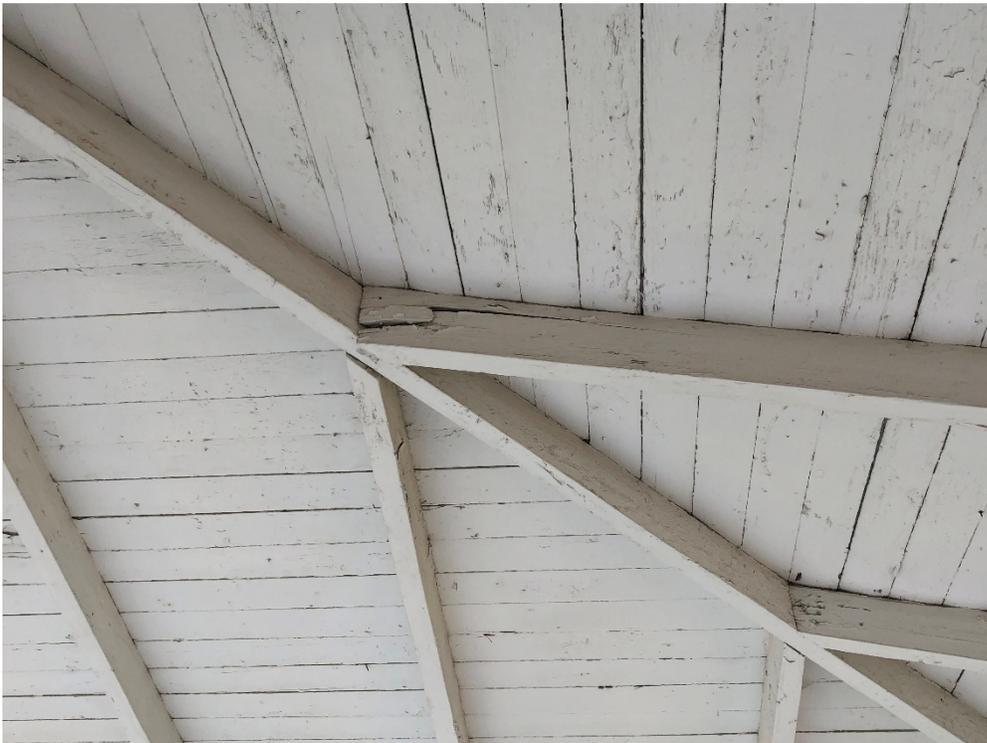
14.0 Split in Porch Rafter

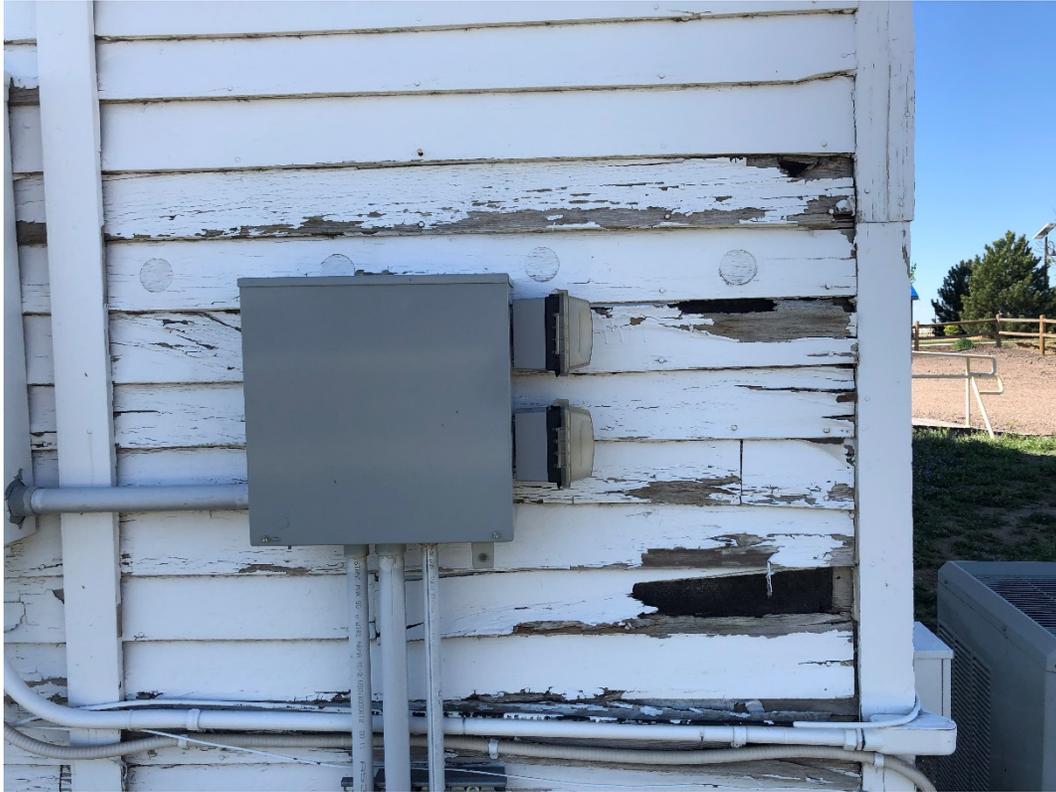
15.0 Siding Deterioration – North Elevation

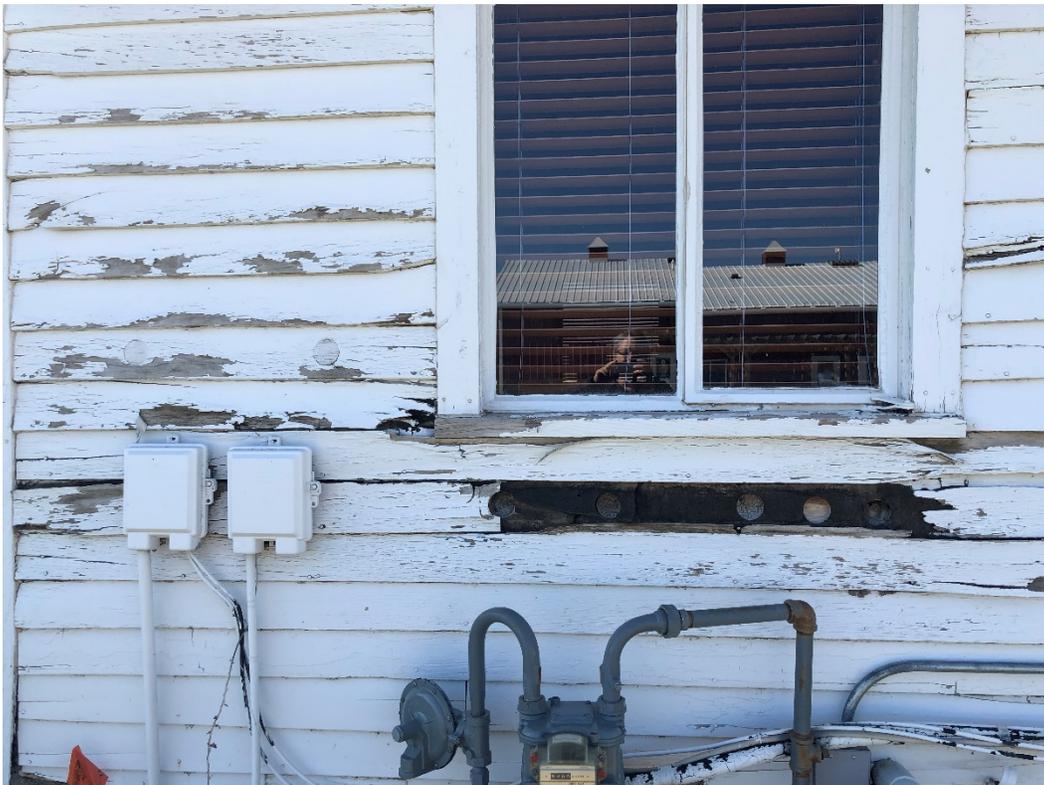
16.0 Deterioration of Siding Where Holes were Drilled for Insulation

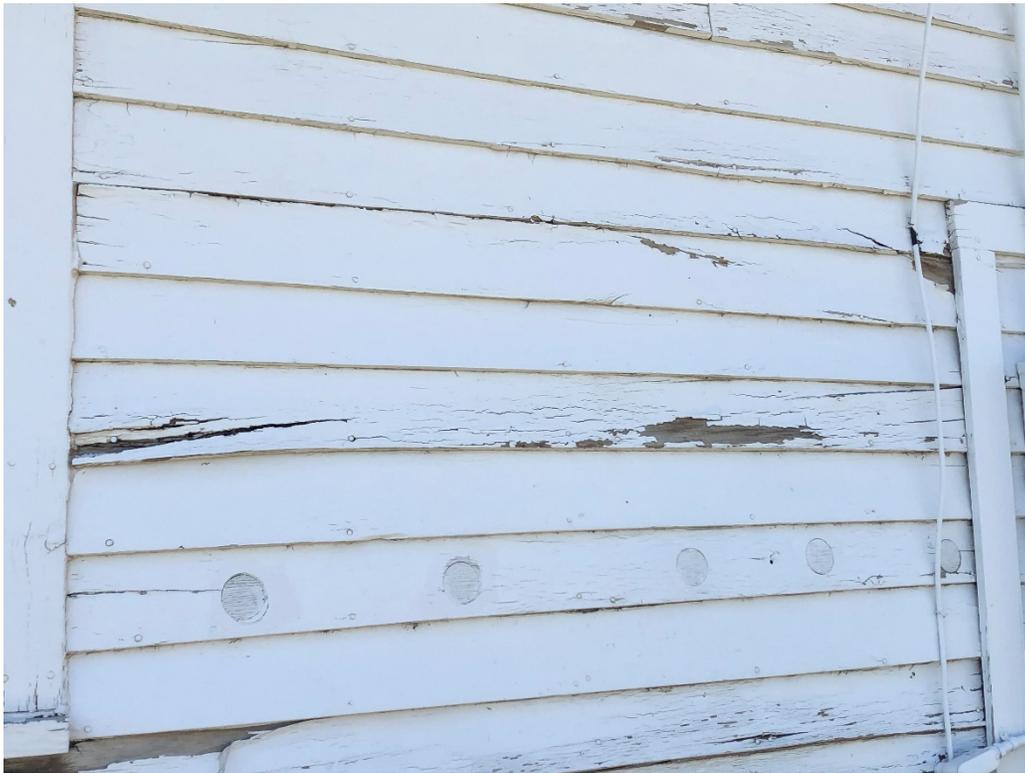
17.0 Holes Drilled for Installation of Blown-In Insulation

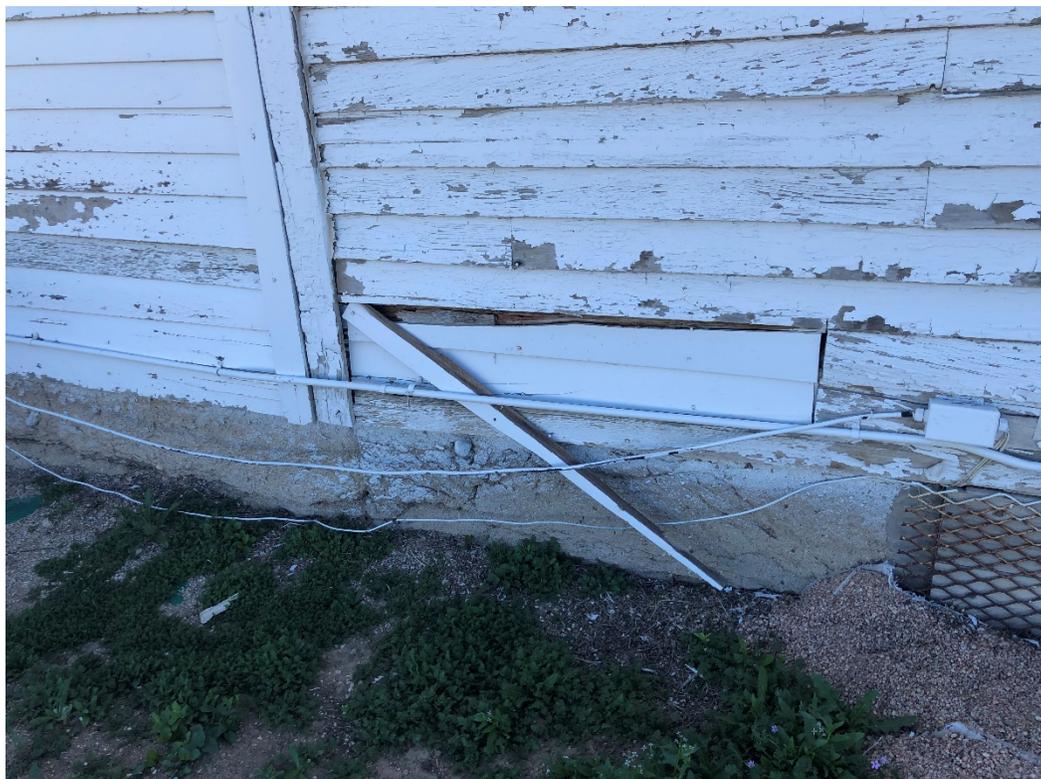
18.0 Siding Deterioration and Inappropriate Siding Installation

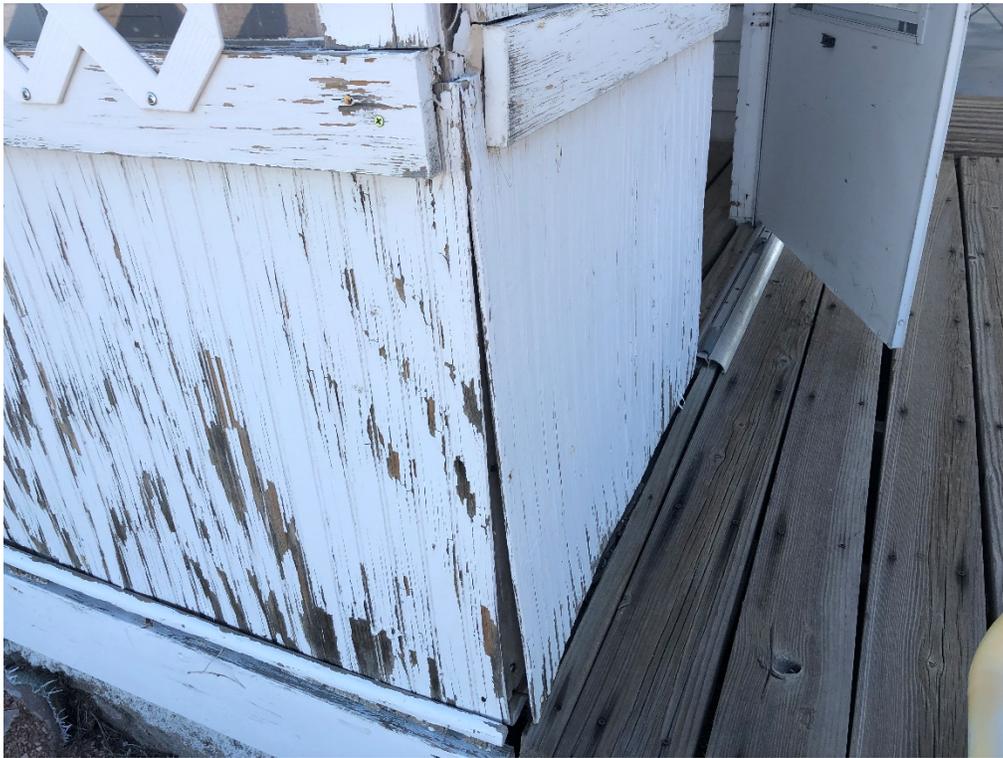
21.0 Deterioration and Loose Beadboard Panel at Screened Porch

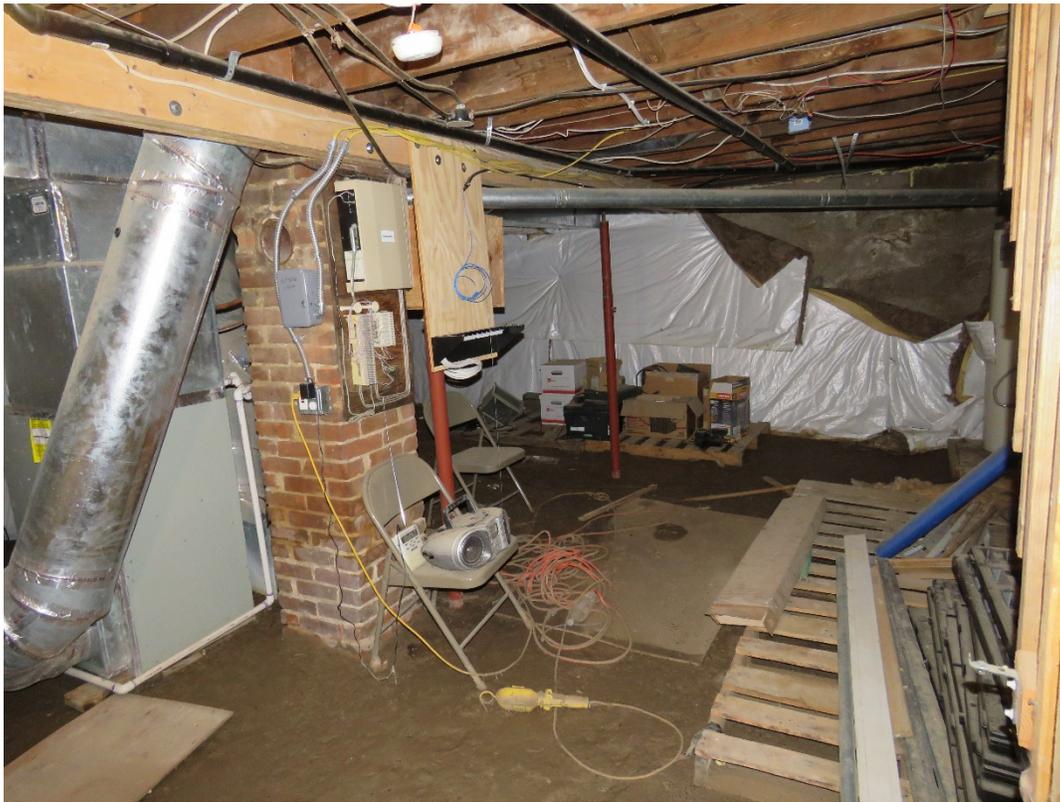
49.0 Basement – Looking West – Note Muddy Floor and Peeling Insulation off of Walls

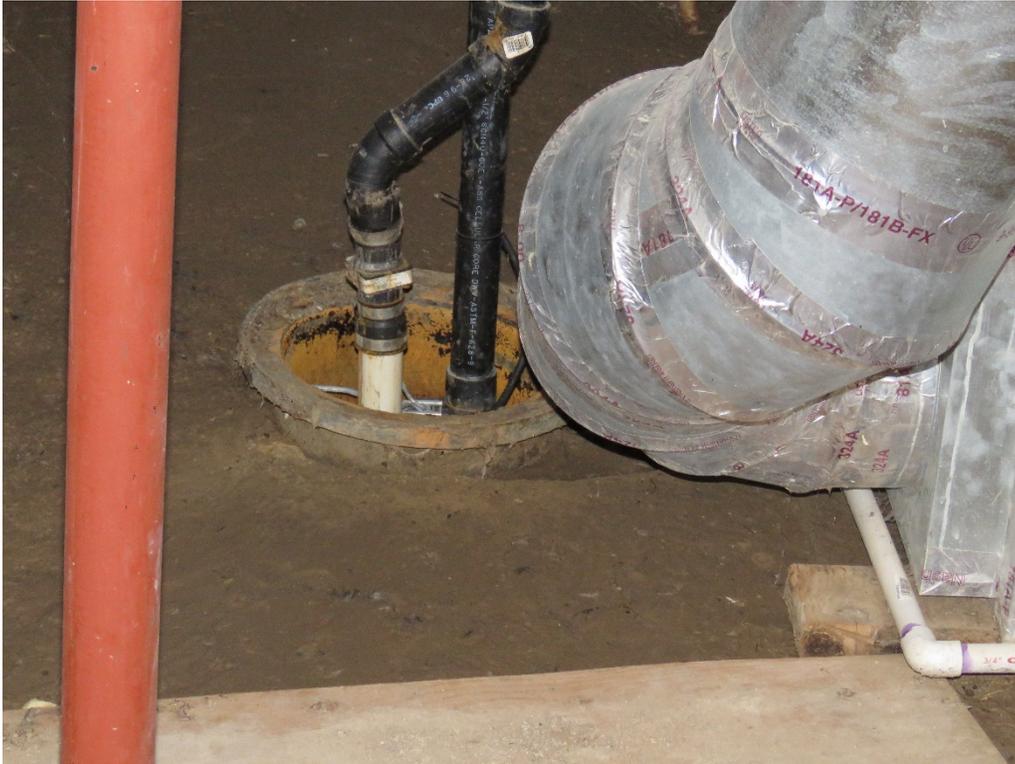
50.0 Basement Sump Pump Sits Above Floor Level
