MUEGGE HOUSE HISTORIC STRUCTURE ASSESSMENT

SHF PROJECT NUMBER 2019-HA-005
DRAFT HISTORIC STRUCTURE ASSESSMENT – DELIVERABLE #4
OCTOBER 20, 2019

CHARLES MUEGGE HOUSE HISTORIC STRUCTURE ASSESSMENT

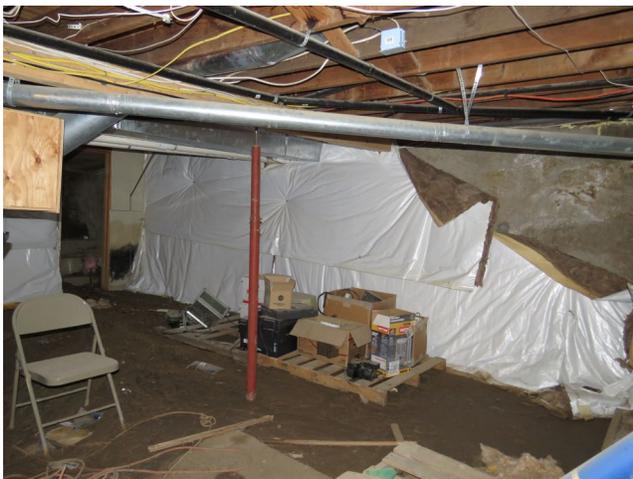
Figure 9 Basement Looking Towards Exterior Stair – Note Mud on Floor and Black Mold on Wall By the Stair

was entering the basement, except that it was near the historic basement stair access. (access to the basement was limited due to the quantity of mud). There is a large area of black mold to the west of the stairs where the team believes the water is entering the building (see Figure 9). There is a large amount of erosion under the wood deck in front of the screened porch at the southwest corner of the building and it is believed that the water is flowing from the property into the southwest corner of the basement at this location (see Figure 2 under Associated Landscape Features). Without doing major demolition, the exact cause is unknown.

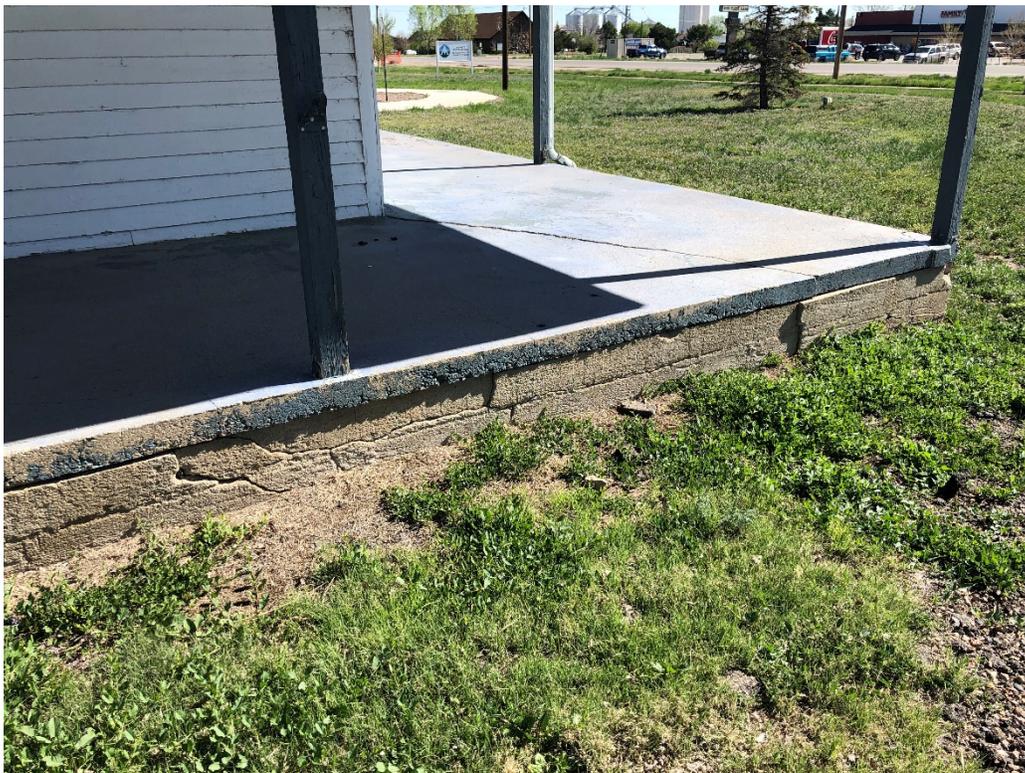
8.0 Concrete Foundation of Porch at South Elevation

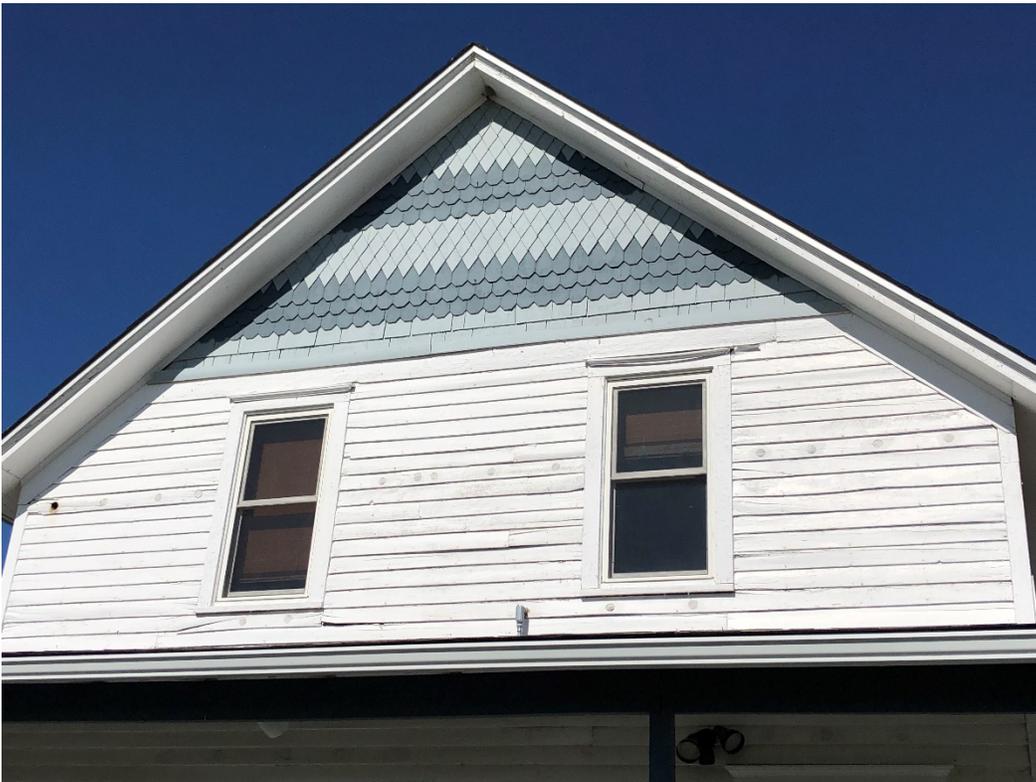
19.0 Siding on the Upper South Elevation

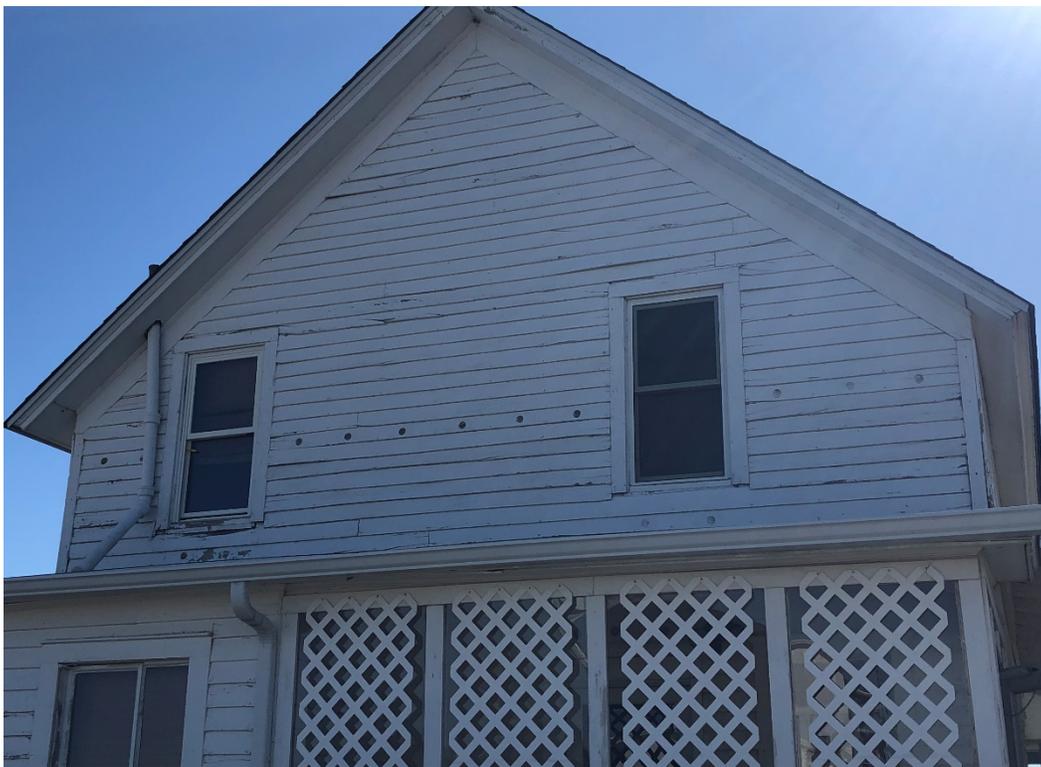
20.0 Siding on the Upper West Elevation

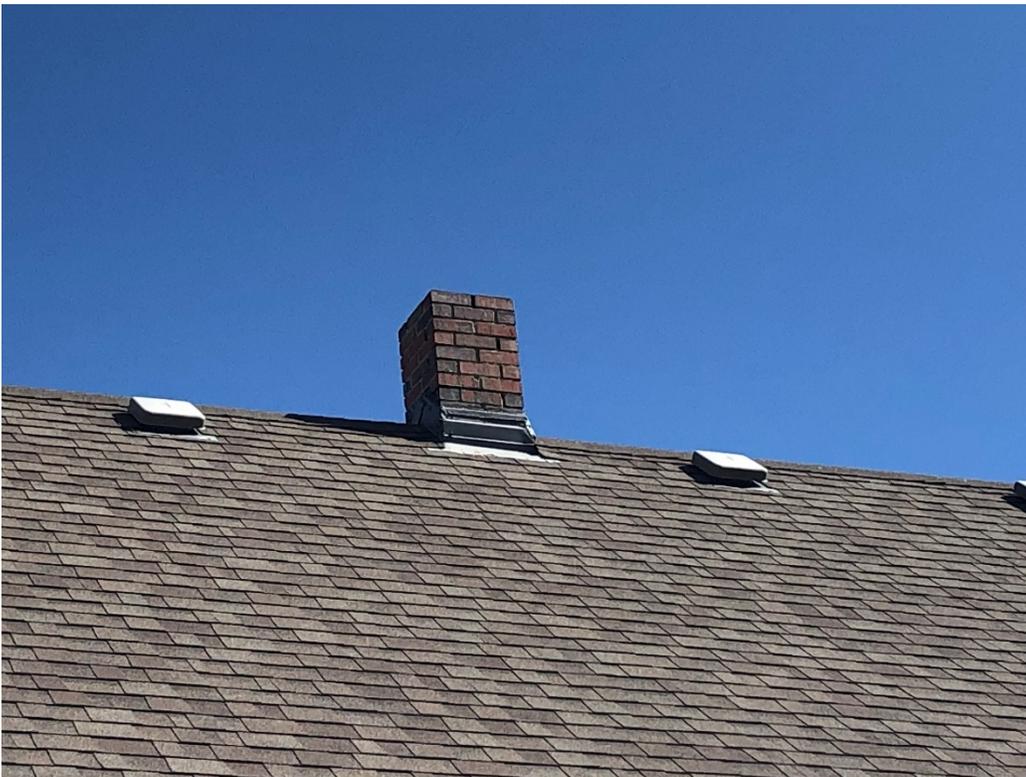
22.0 Chimney and Roof Ventilation

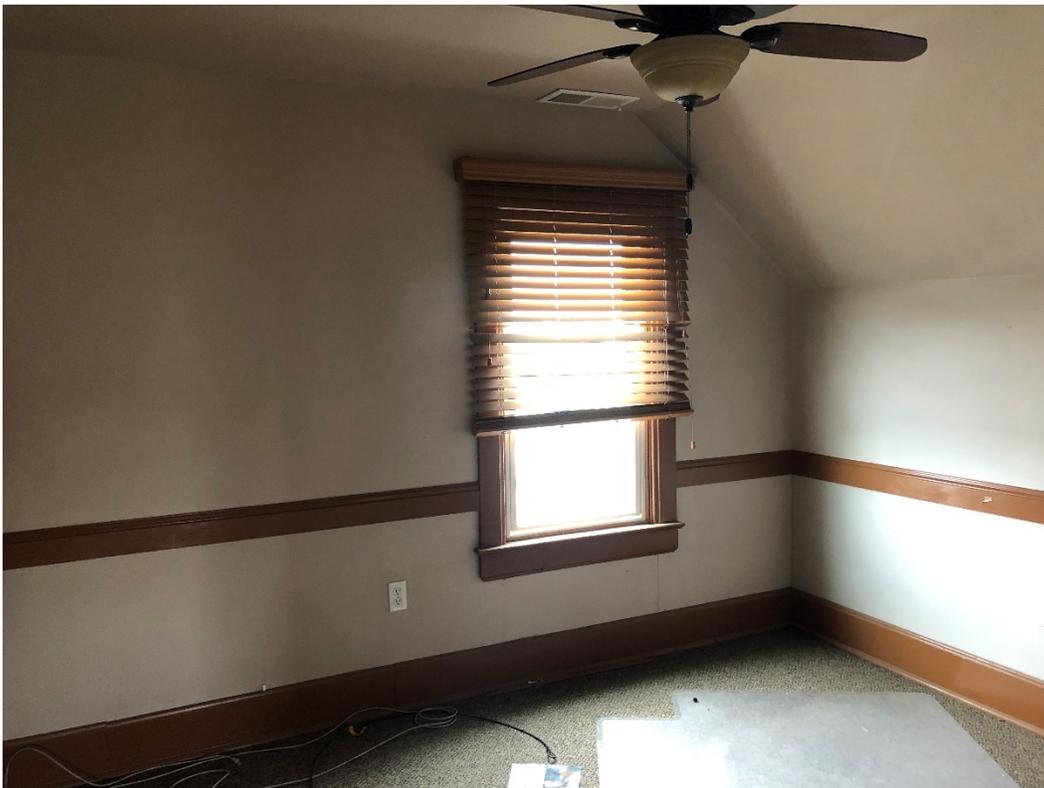
47.0 Office 204 – Looking West

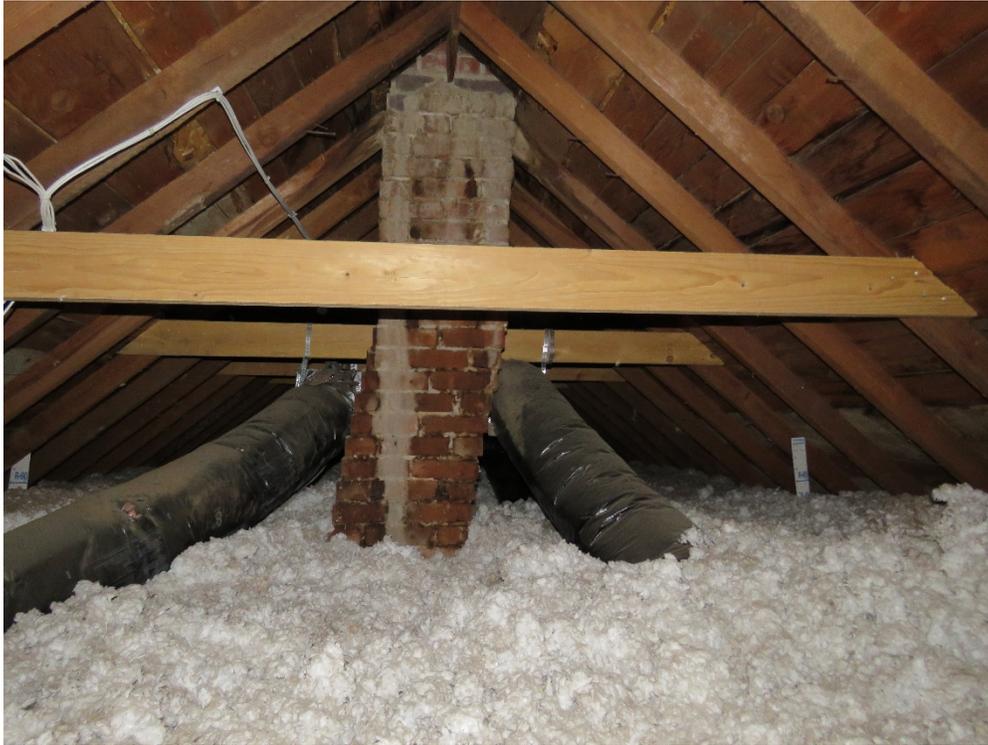
48.0 Attic with Insulation and Chimney

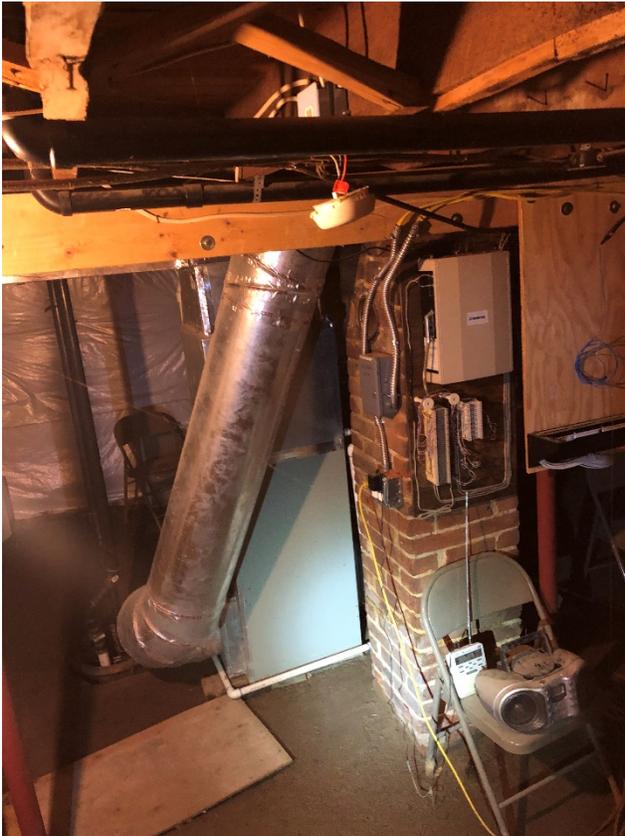
51.0 HVAC Unit in Basement

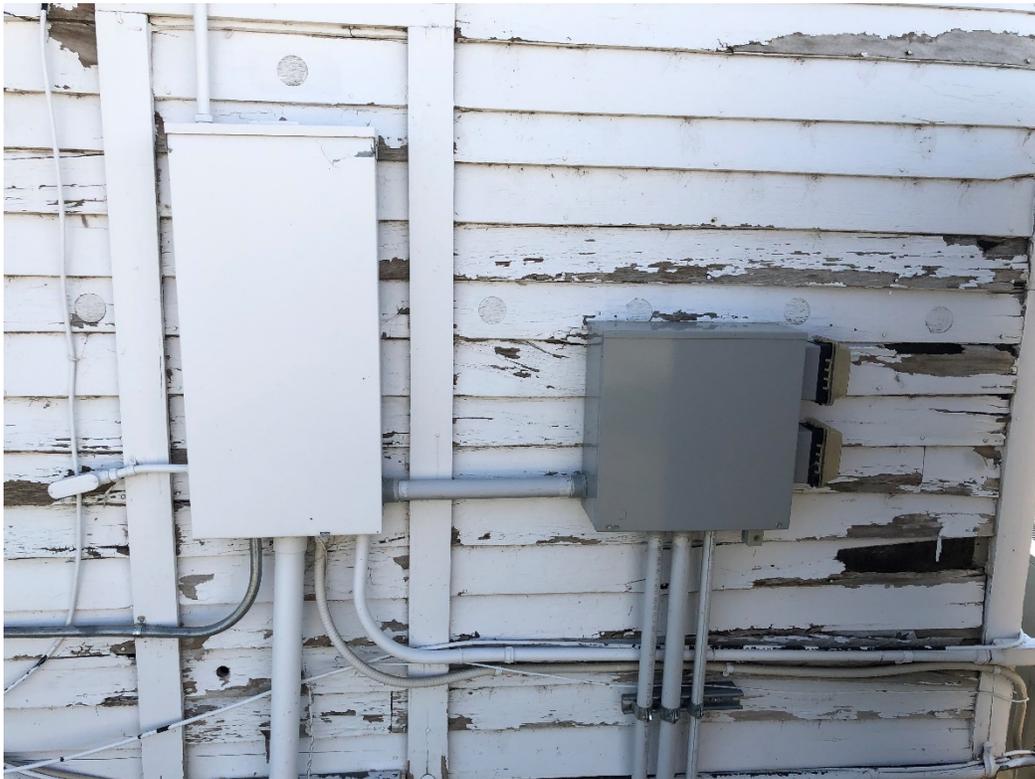
52.0 Electrical Panels on North Side of House – Fed From Power Pole

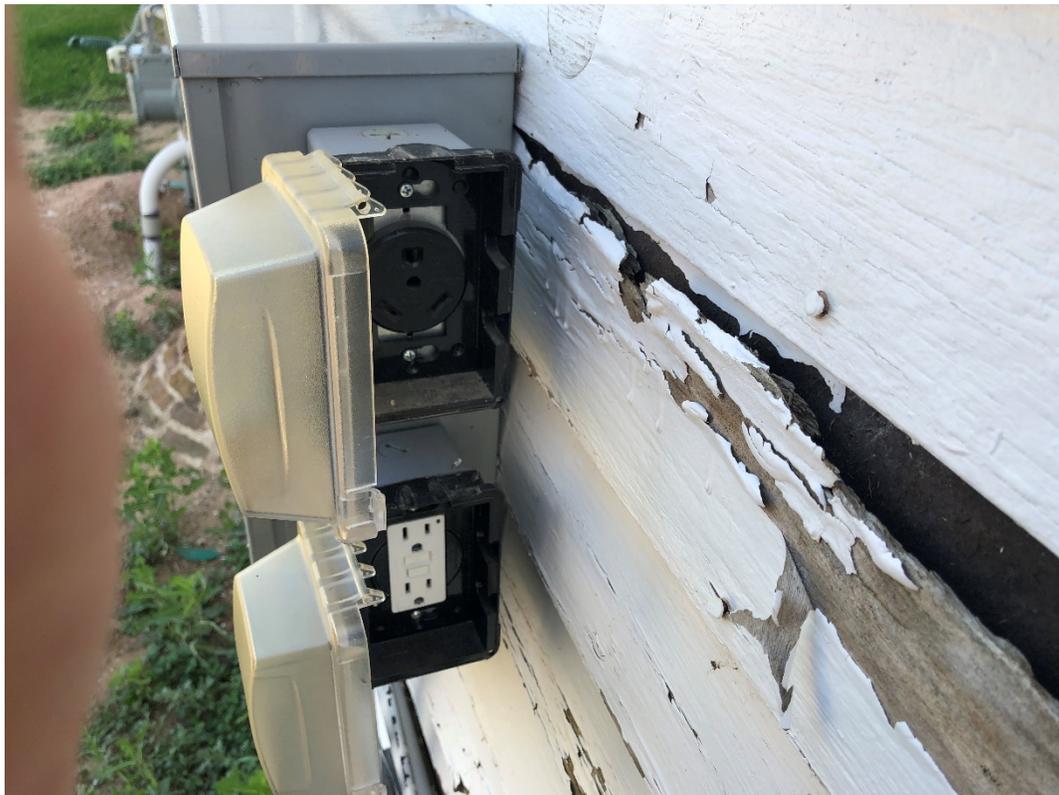
53.0 Outlets on Side of the Electrical Panel
